Aircraft On-Board Navigation Data Integrity

A Serious Problem

Transport Canada Database Working Group Paper

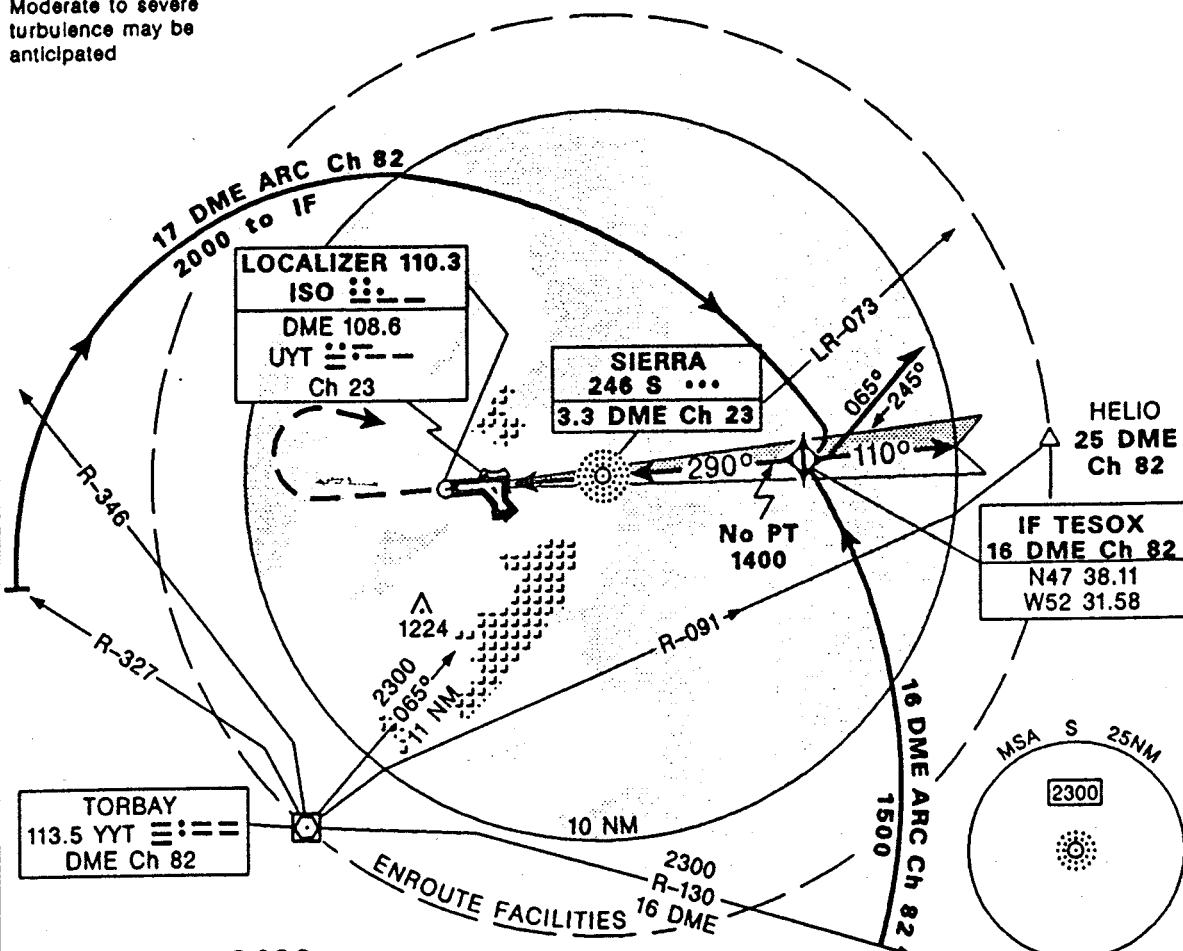
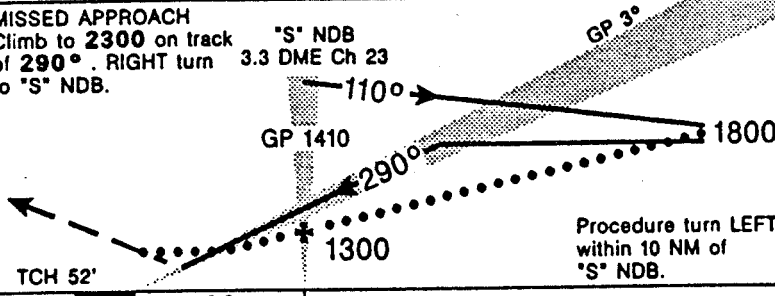
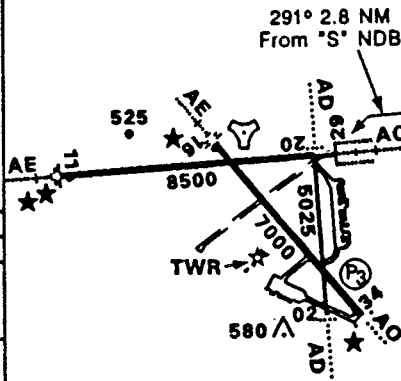
Fortunately, this occurred just prior to a review of a major manufacturers new equipment, and TC, working with the FMS manufacturer was able to identify the cause of the problem. Other FMS manufacturers did not appear to be aware of the problem.

If this had not been found on a routine check, it is uncertain how long the problem would have persisted.

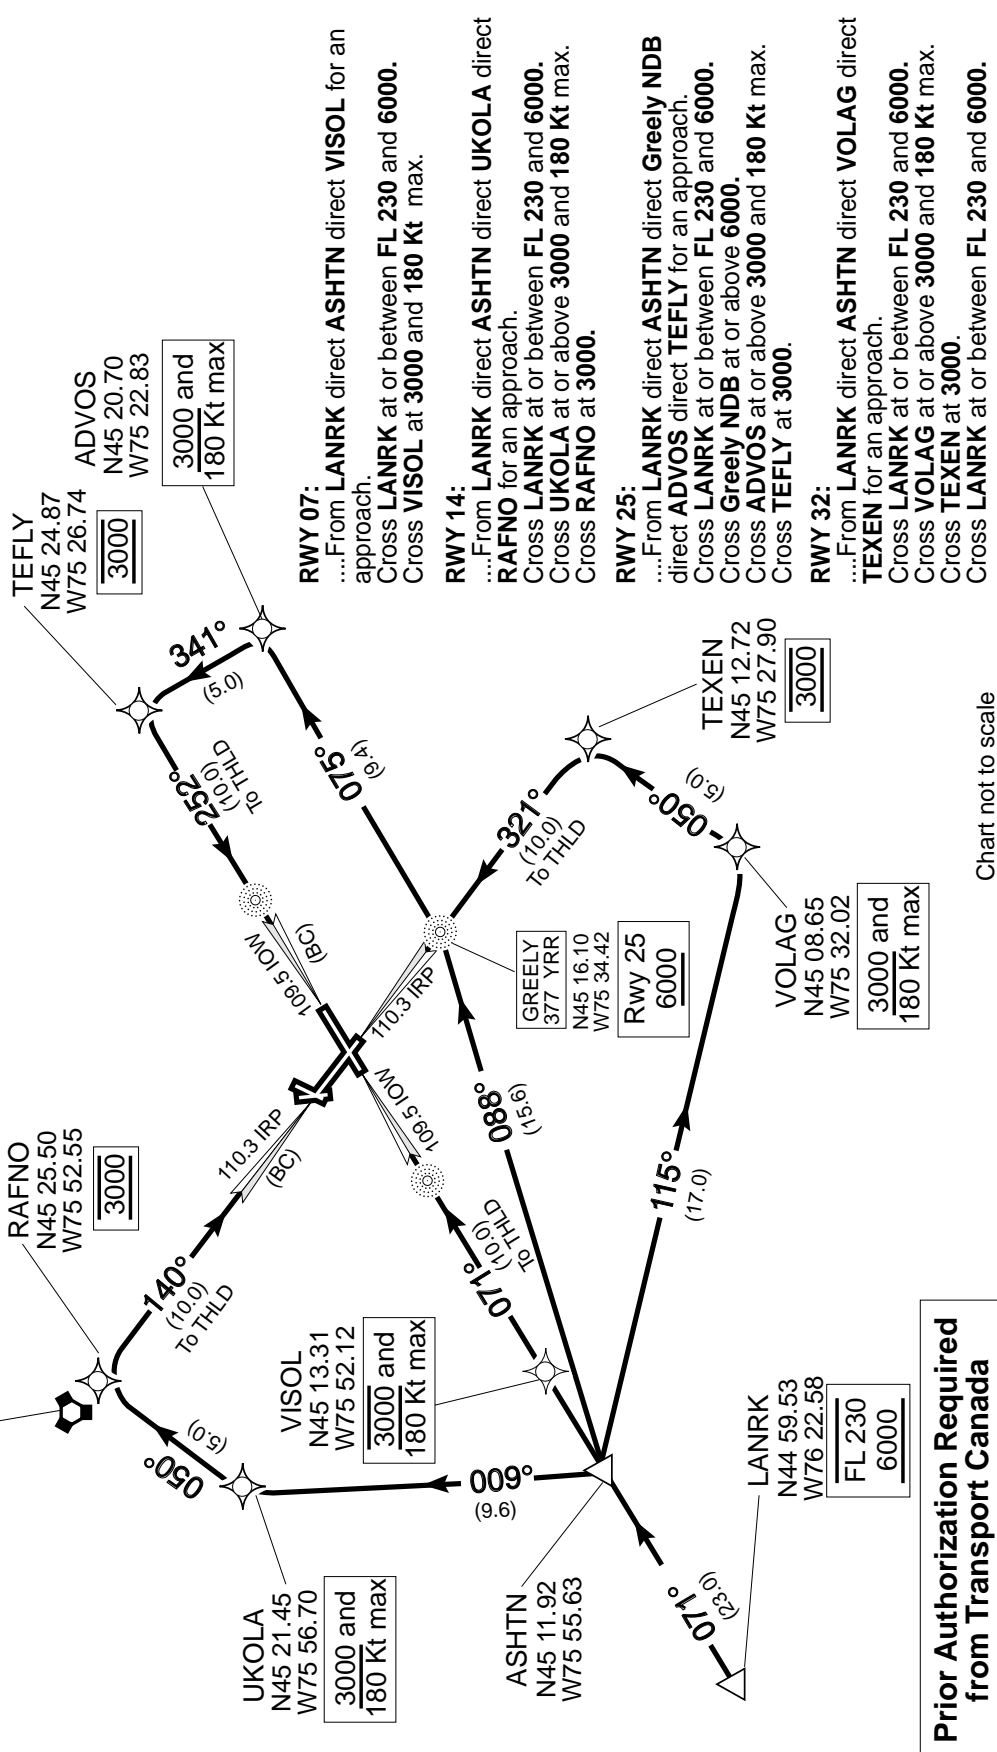
It should be noted that the ARINC 424 localizer intercept implementation feature has the following characteristics:

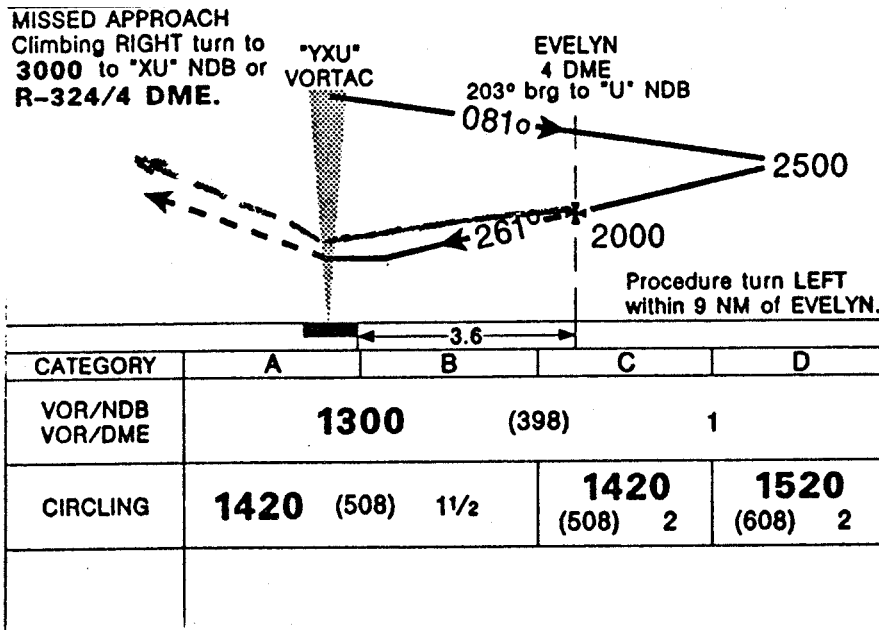
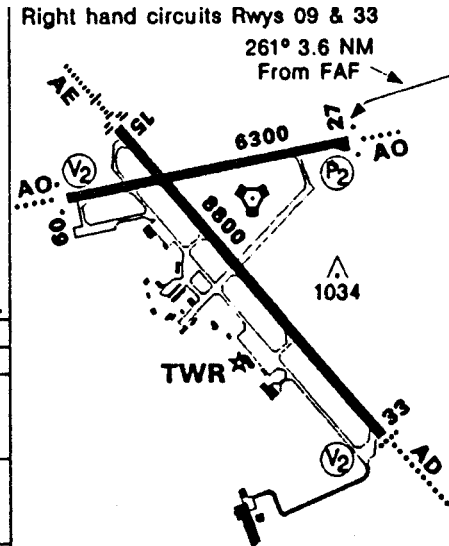
The published approach calls for a descent from the 2000' height at EVELYN FAF to 1300 prior to the runway. This is a typical non-precision approach with an MDA. It is expected that the aircraft would be leveled at 1300' well before the runway, and be in a position to land if the runway was sighted. If the runway was not sighted the aircraft would continue at that altitude until the YXU VOR was crossed at which point the missed approach procedure would be carried out.

The FMS approach calls for the 'pseudo' glide path to terminate at 1300', but only when the aircraft is over the middle of the airfield. The missed approach point is taken as the YXU VOR, resulting in a very shallow glidepath. The aircraft would not be at 1300' until the middle of the airfield, which is too high to permit a safe landing to be made on Runway 27 without circling. (The circling approach minima is 1420'). Instead of being at an appropriate altitude prior to the runway, the FMS procedure keeps the aircraft high until well past the approach end of the runway.
