The Cairns Tilt-Train Derailment in Queensland

An Overview and Partial Analysis

Prof. Peter B. Ladkin PhD
ladkin@rvs.uni-bielefeld.de

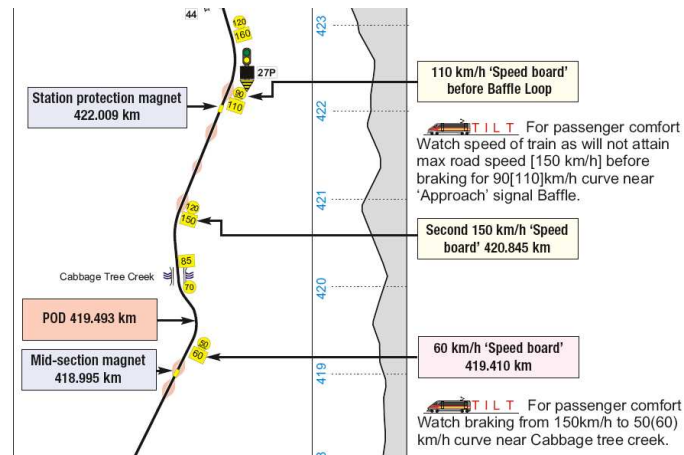
The Point of Derailment

- Point of Derailment (**POD**) was 83 **m** beyond the Speed Board (**SPB**) restricting the **CTT** to 60 **kph**. It was travelling at 112 **kph** at the **POD**.
- This 60-kph **SPB** was 415 **m** beyond the Mid-Section Magnet (**MSM**)
- The **MSM** lies 1.212 **km** beyond a 150-kph **SPB**.
- The **MSM** lies 3.525 **km** beyond the Station Protection Magnet (**SPM**) at **BO** and 3.014 **km** before the **SPM** at **BA**.
- On the 1.6 **km** stretch from the 150-kph **SPB** to the 60-kph **SPB**, the **CTT** had accelerated from 80 **kph** to 111 **kph** under steady power.

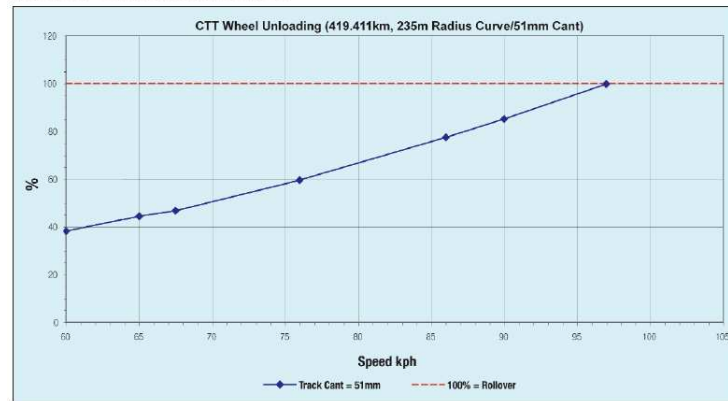
FIGURE 14: Wheel Unloading vs Speed

- The train was travelling at 112 kph at POD
- The left-hand curve at CTC was posted for 60 kph for the Tilt Train (50 kph for others)
- Tipover: full wheel unloading for lead power car of DMU at CTC would have occurred at about 97 kph
 - post-accident modelling with *Vampire* (Sec 2.6)

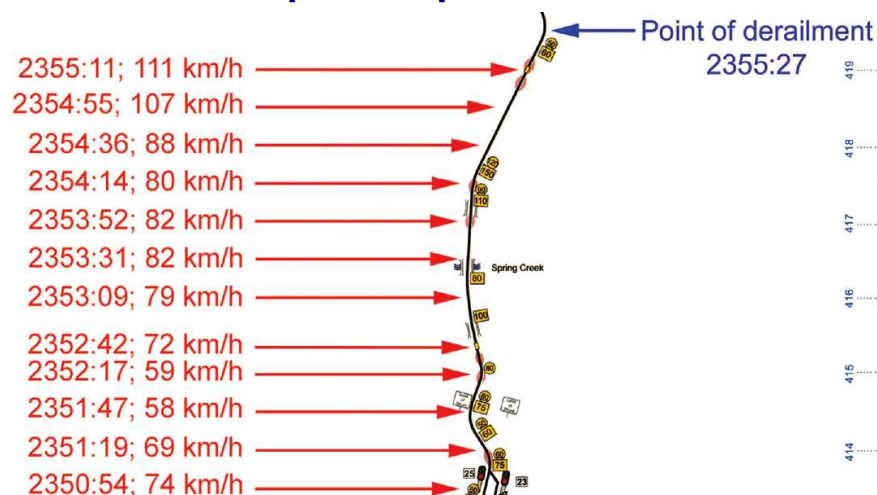
Speeds up to POD

- One block from BO to BA
 - block occupied by the CTT at the time
- Before BO, CTT had attained 154 kph and then slowed as required
- Driver had maintained at or below posted speed up to (83 m before) POD
 - after BO, 74 kph → 58 kph → 111 kph
 - After BO SPM, 72 kph → 111 kph
 - After 150-kph speed board, 80+ kph → 111 kph
 - Note: train is physically unable to attain 150 kph in this short 1.627-km segment before the CTC 60-kph speed board
 - did not slow at MSM

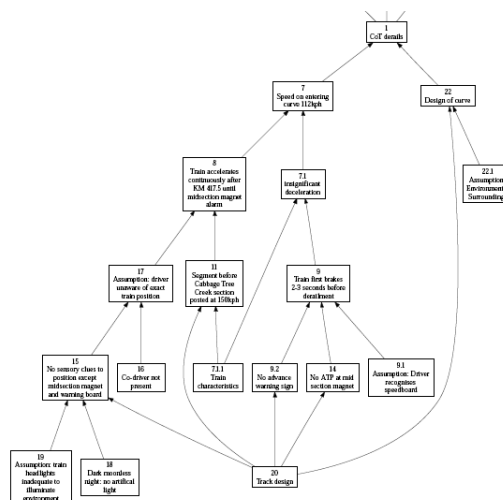
WBG Lower Part: Causes of Derailment

- The WBG is sparse
 - 23 nodes altogether, 18 nodes precursory to derailment
- However, it does identify significant issues
 - Track design: 5 out-edges!
 - Design of curve (general topography of track in vicinity)
 - 1.627 km segment posted 150 kph followed by posted-60-kph curve
 - MSM 0.415 km before 60-kph SPB
 - Few sensory clues to position
 - SPB and MSM
 - Moonless night. Headlights inadequate?
 - Train
 - accelerated continuously for 4+ km previous to POD
 - braked 2-3 sec before derailment (driver saw 60-kph SPB?)
