Analysis of the Royal Majesty Grounding Using SOL

Claire Blackett

3rd Bieleschweig Workshop on Systems Engineering

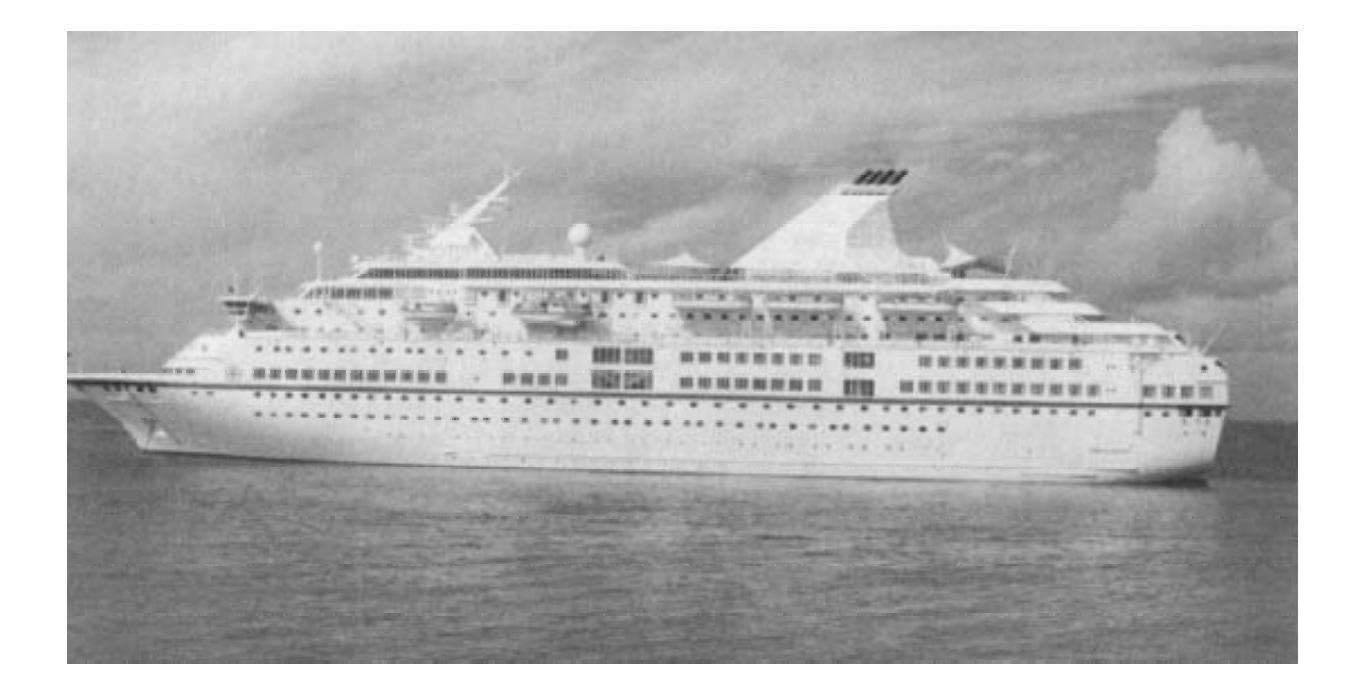
• The Royal Majesty Cruise Ship before the accident.

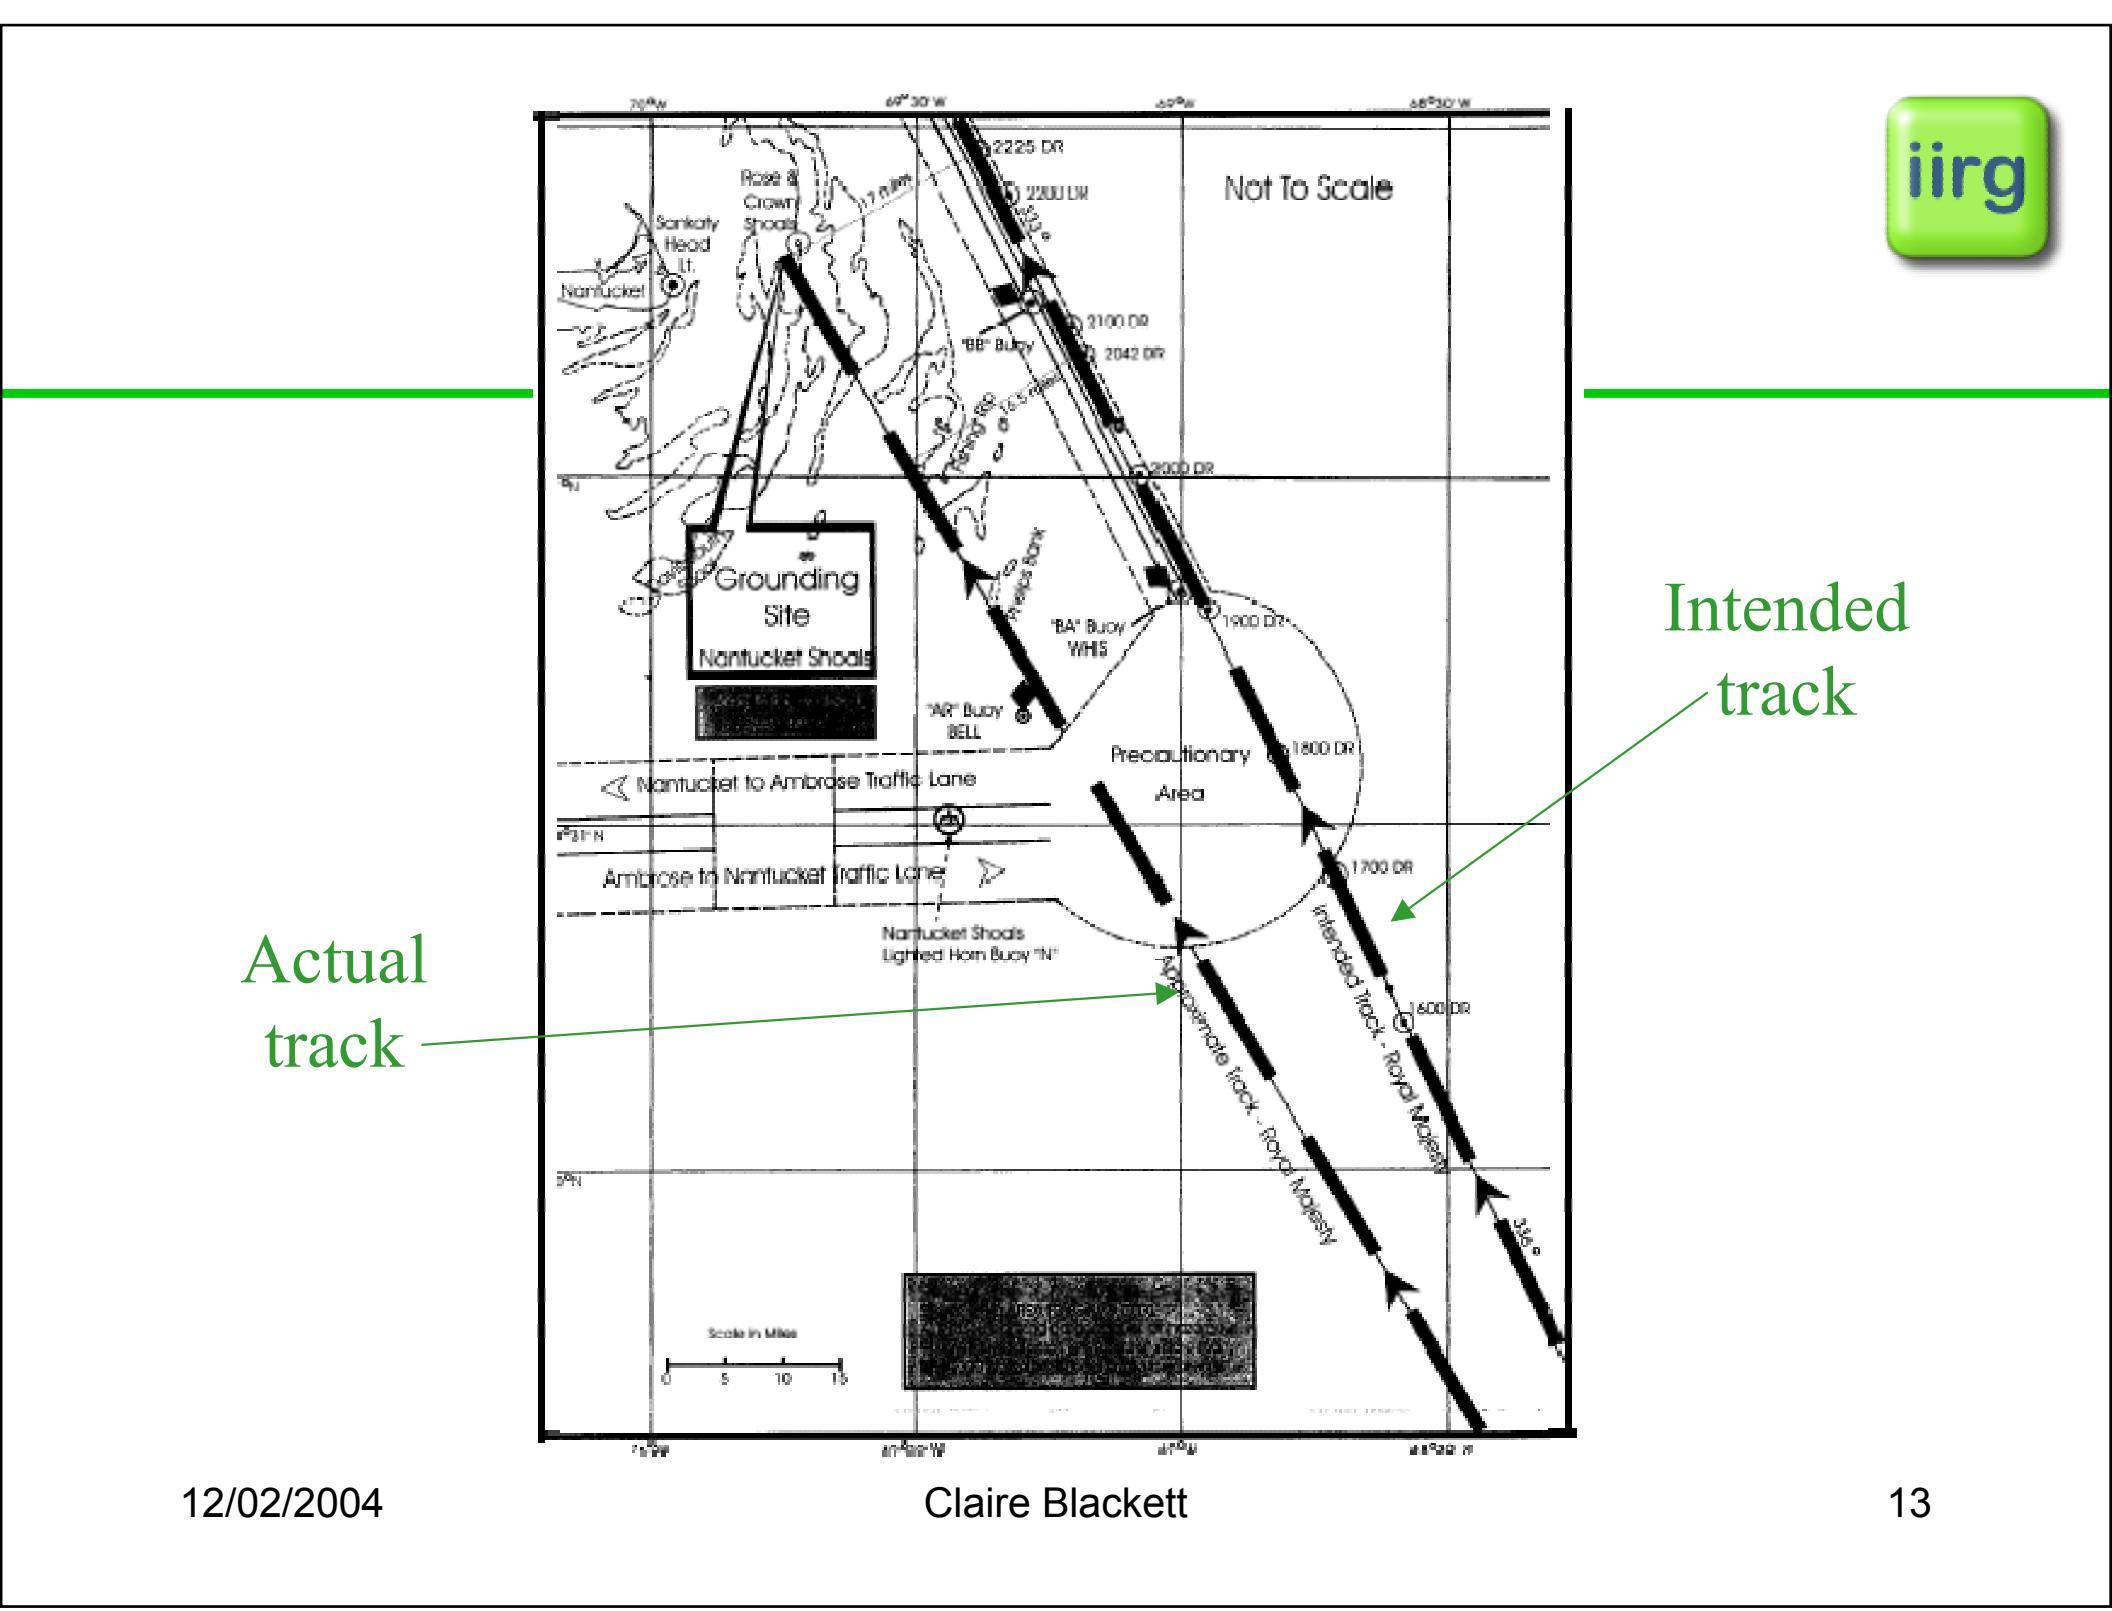
- The Master then had the GPS and Loran-C navigation aids checked, and realized for the first time that the GPS position data was in error by at least 15 miles.
- The ship had actually grounded 17 miles away from its programmed track.

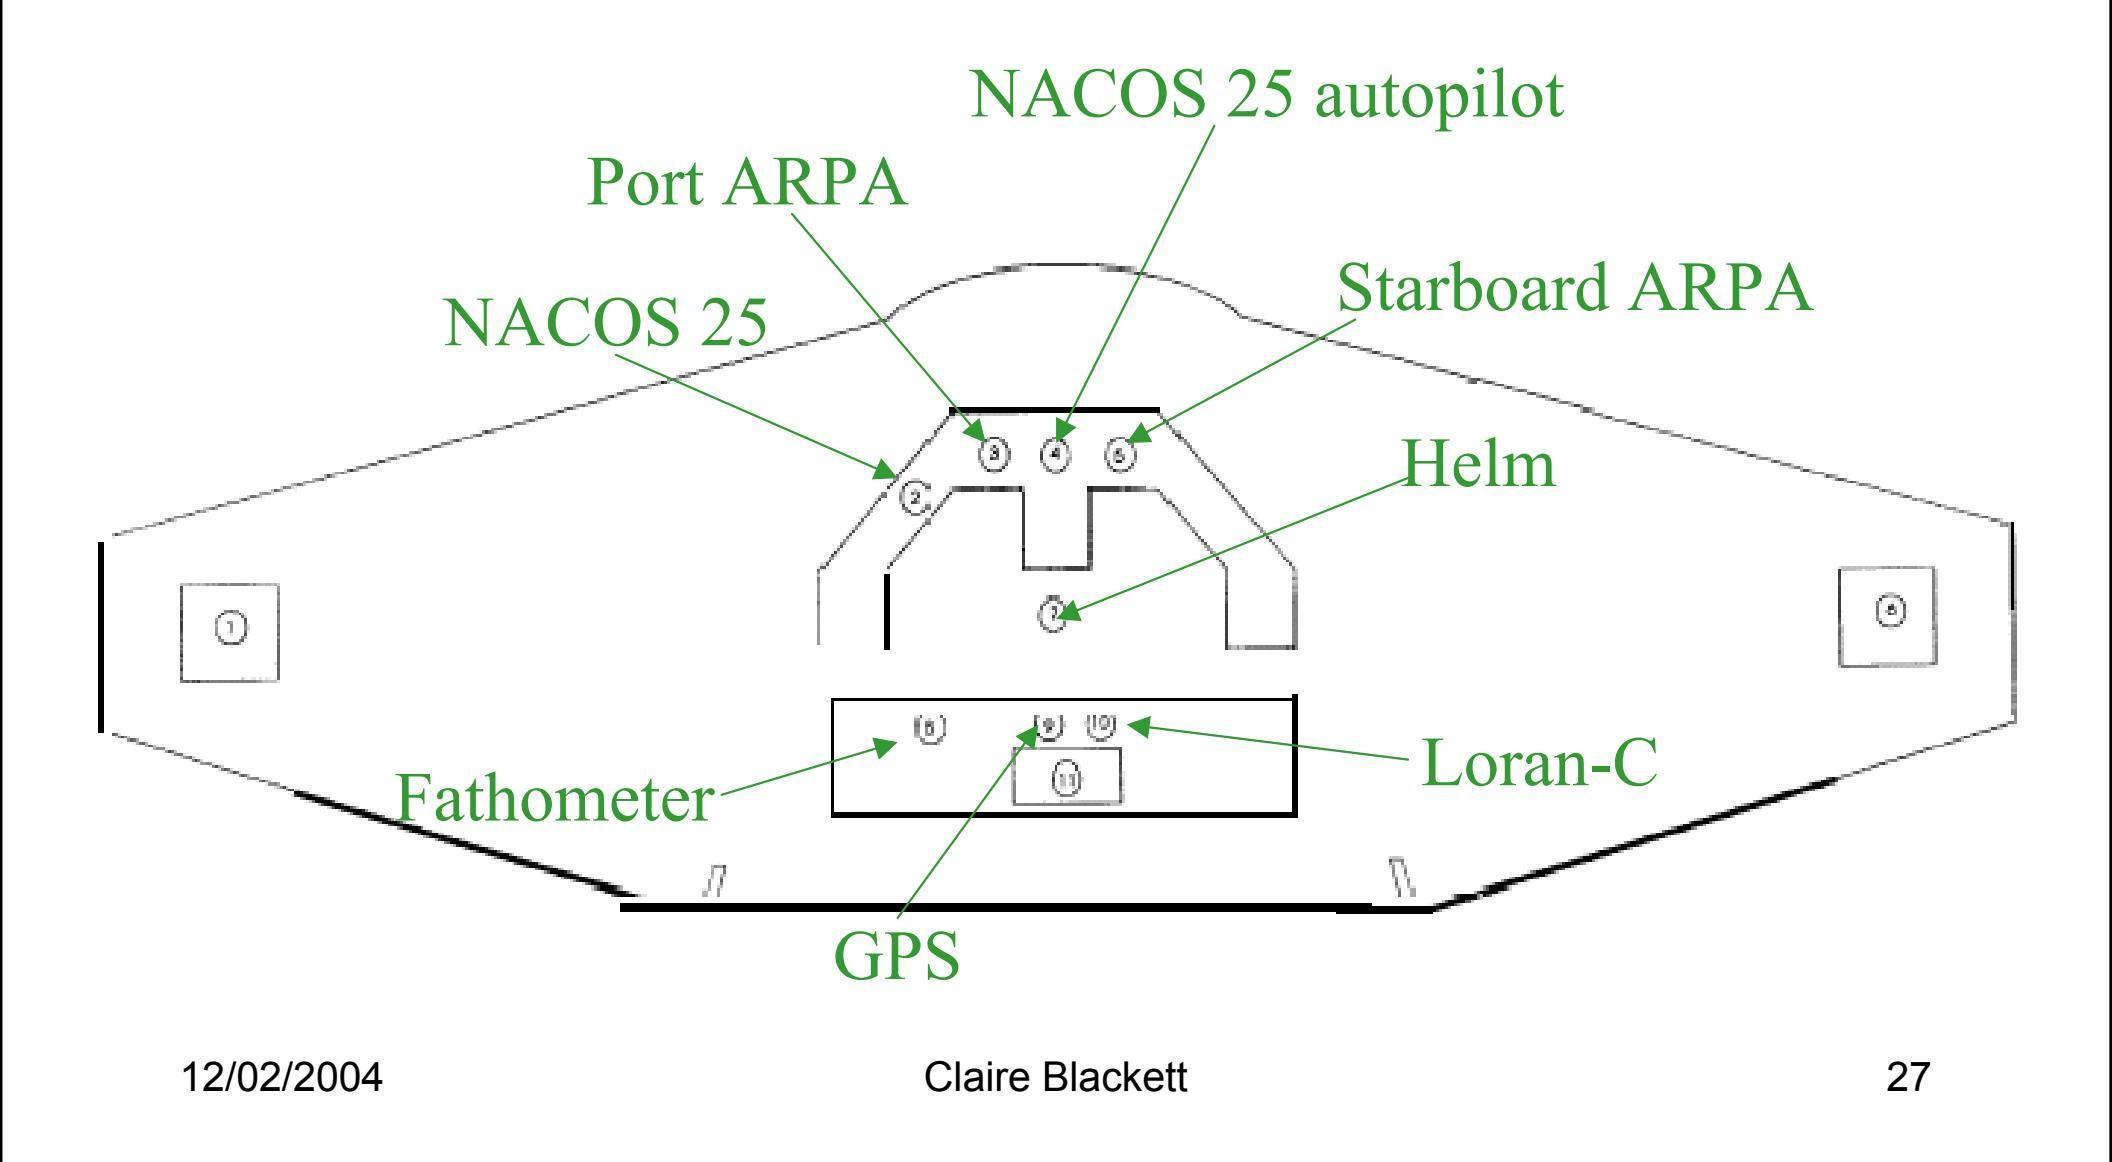
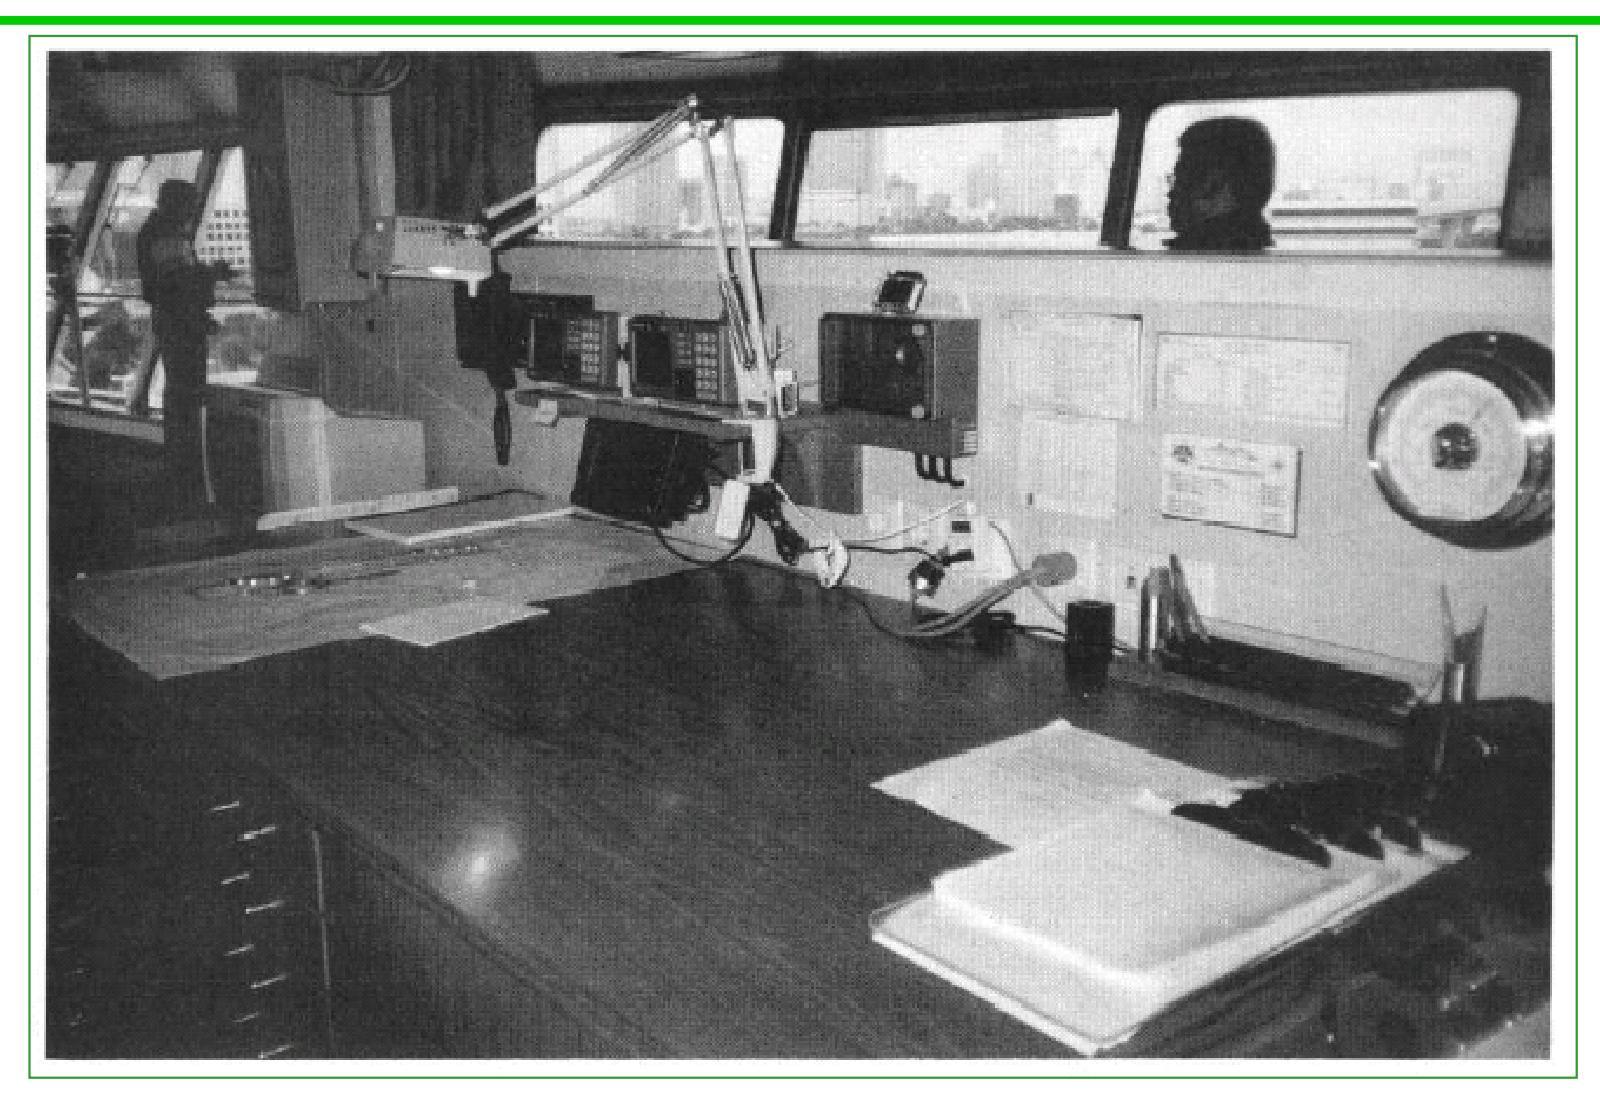
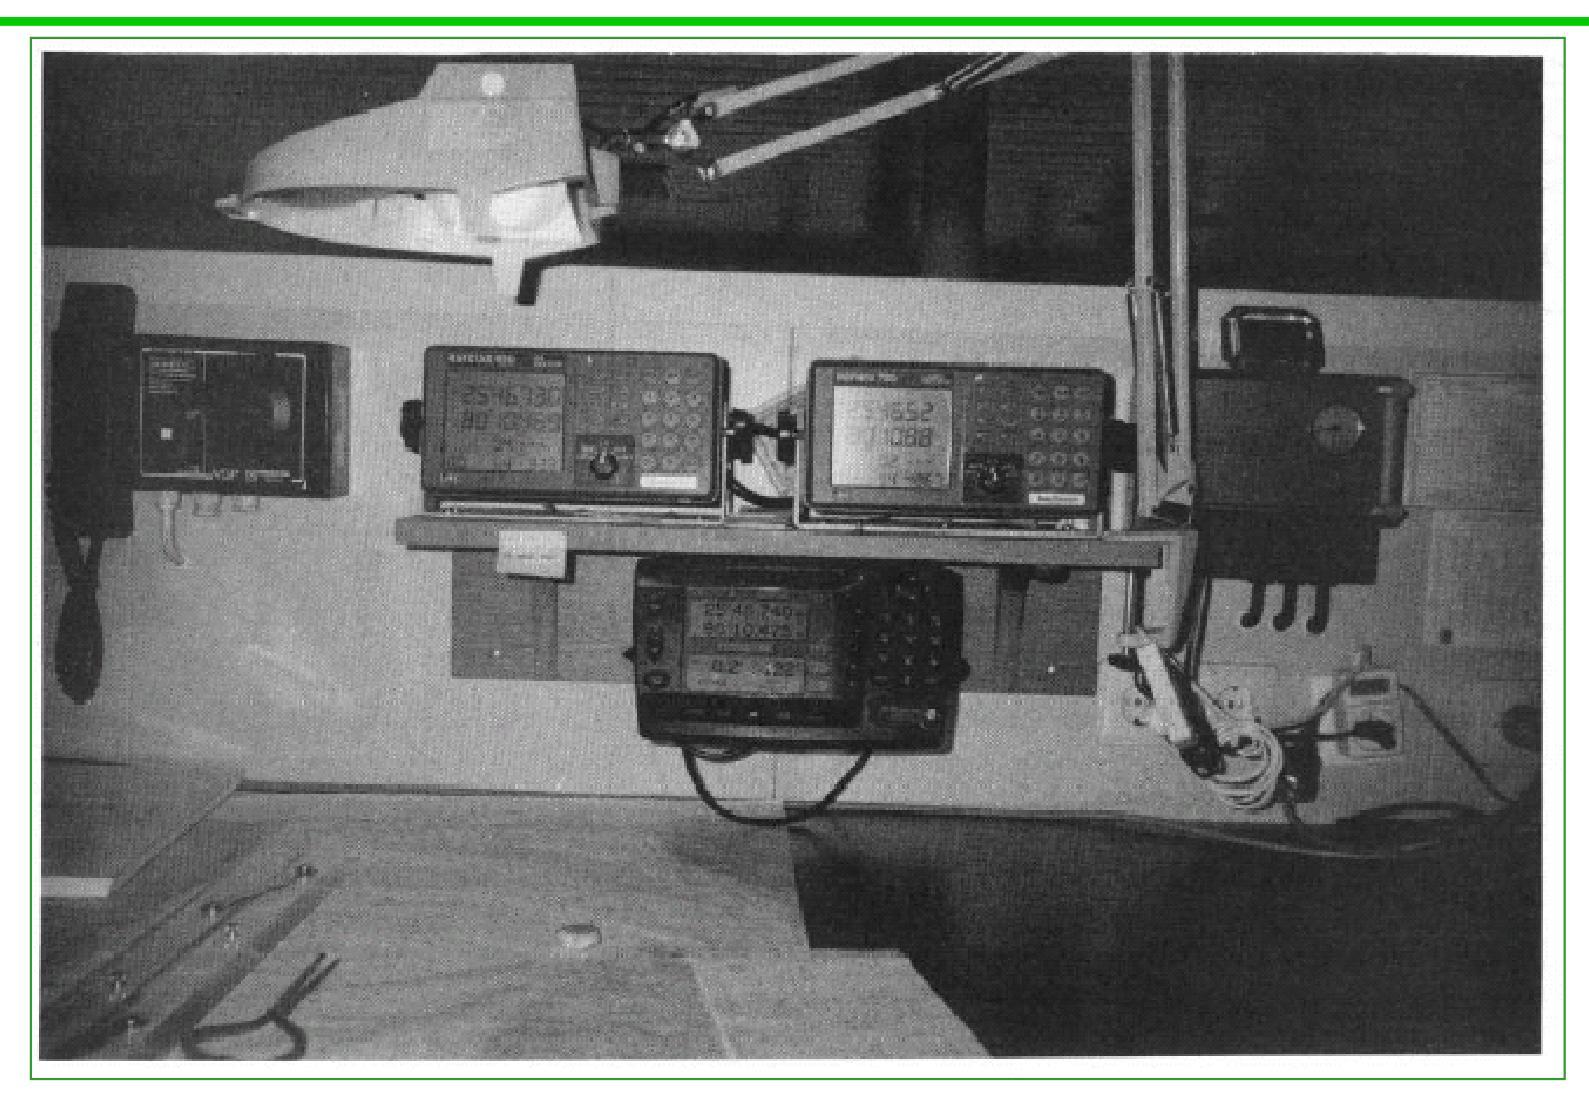
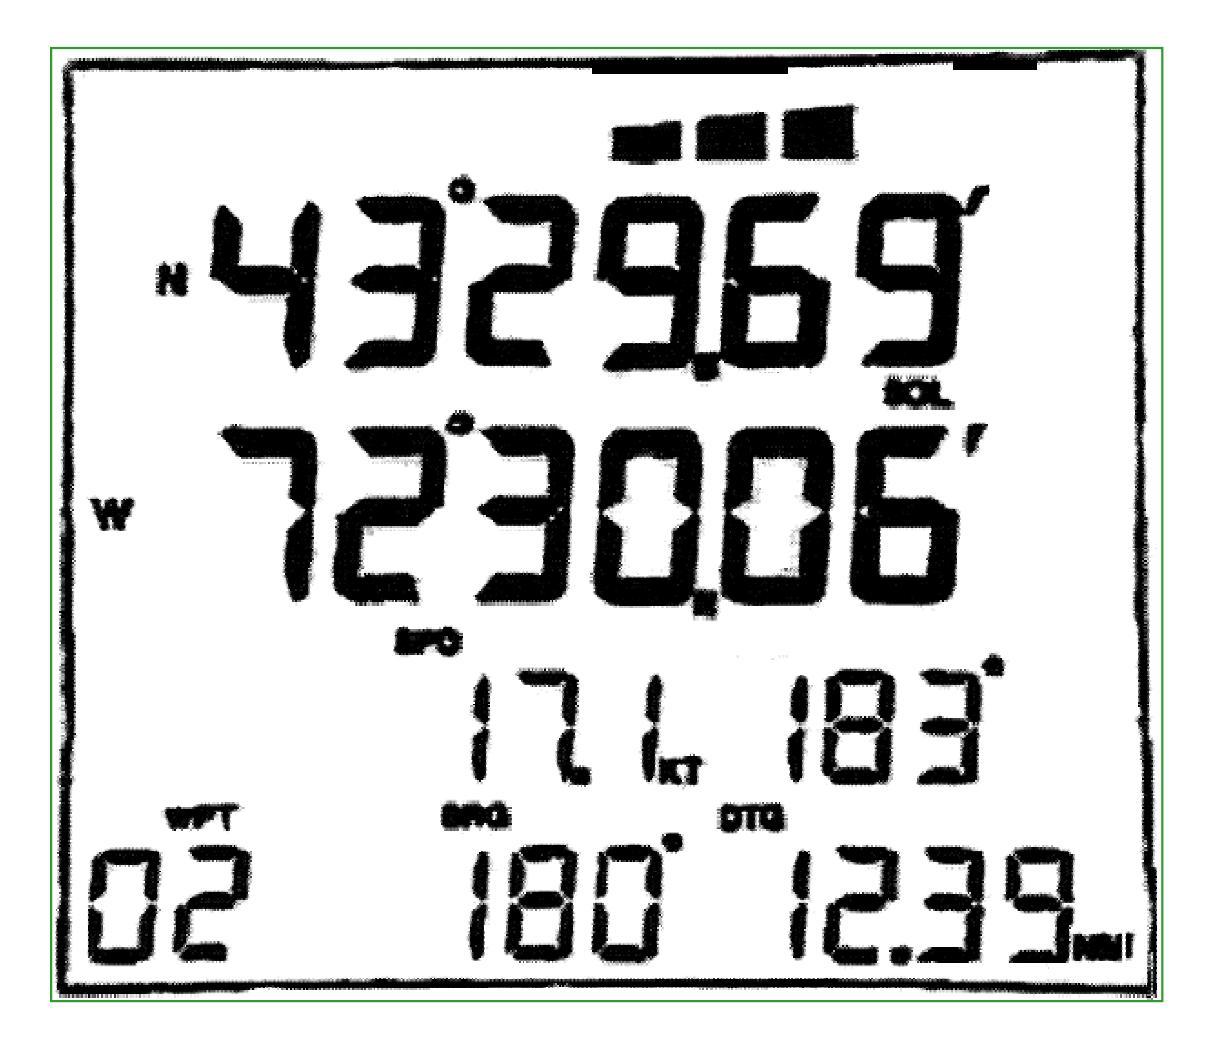
- Representation of Information
 - The position of the GPS and Loran-C displays, in relation to the helm.
 - The displays are also relatively small.
 - The displays could be out of earshot, meaning that alarms would be difficult to hear if they sounded.
