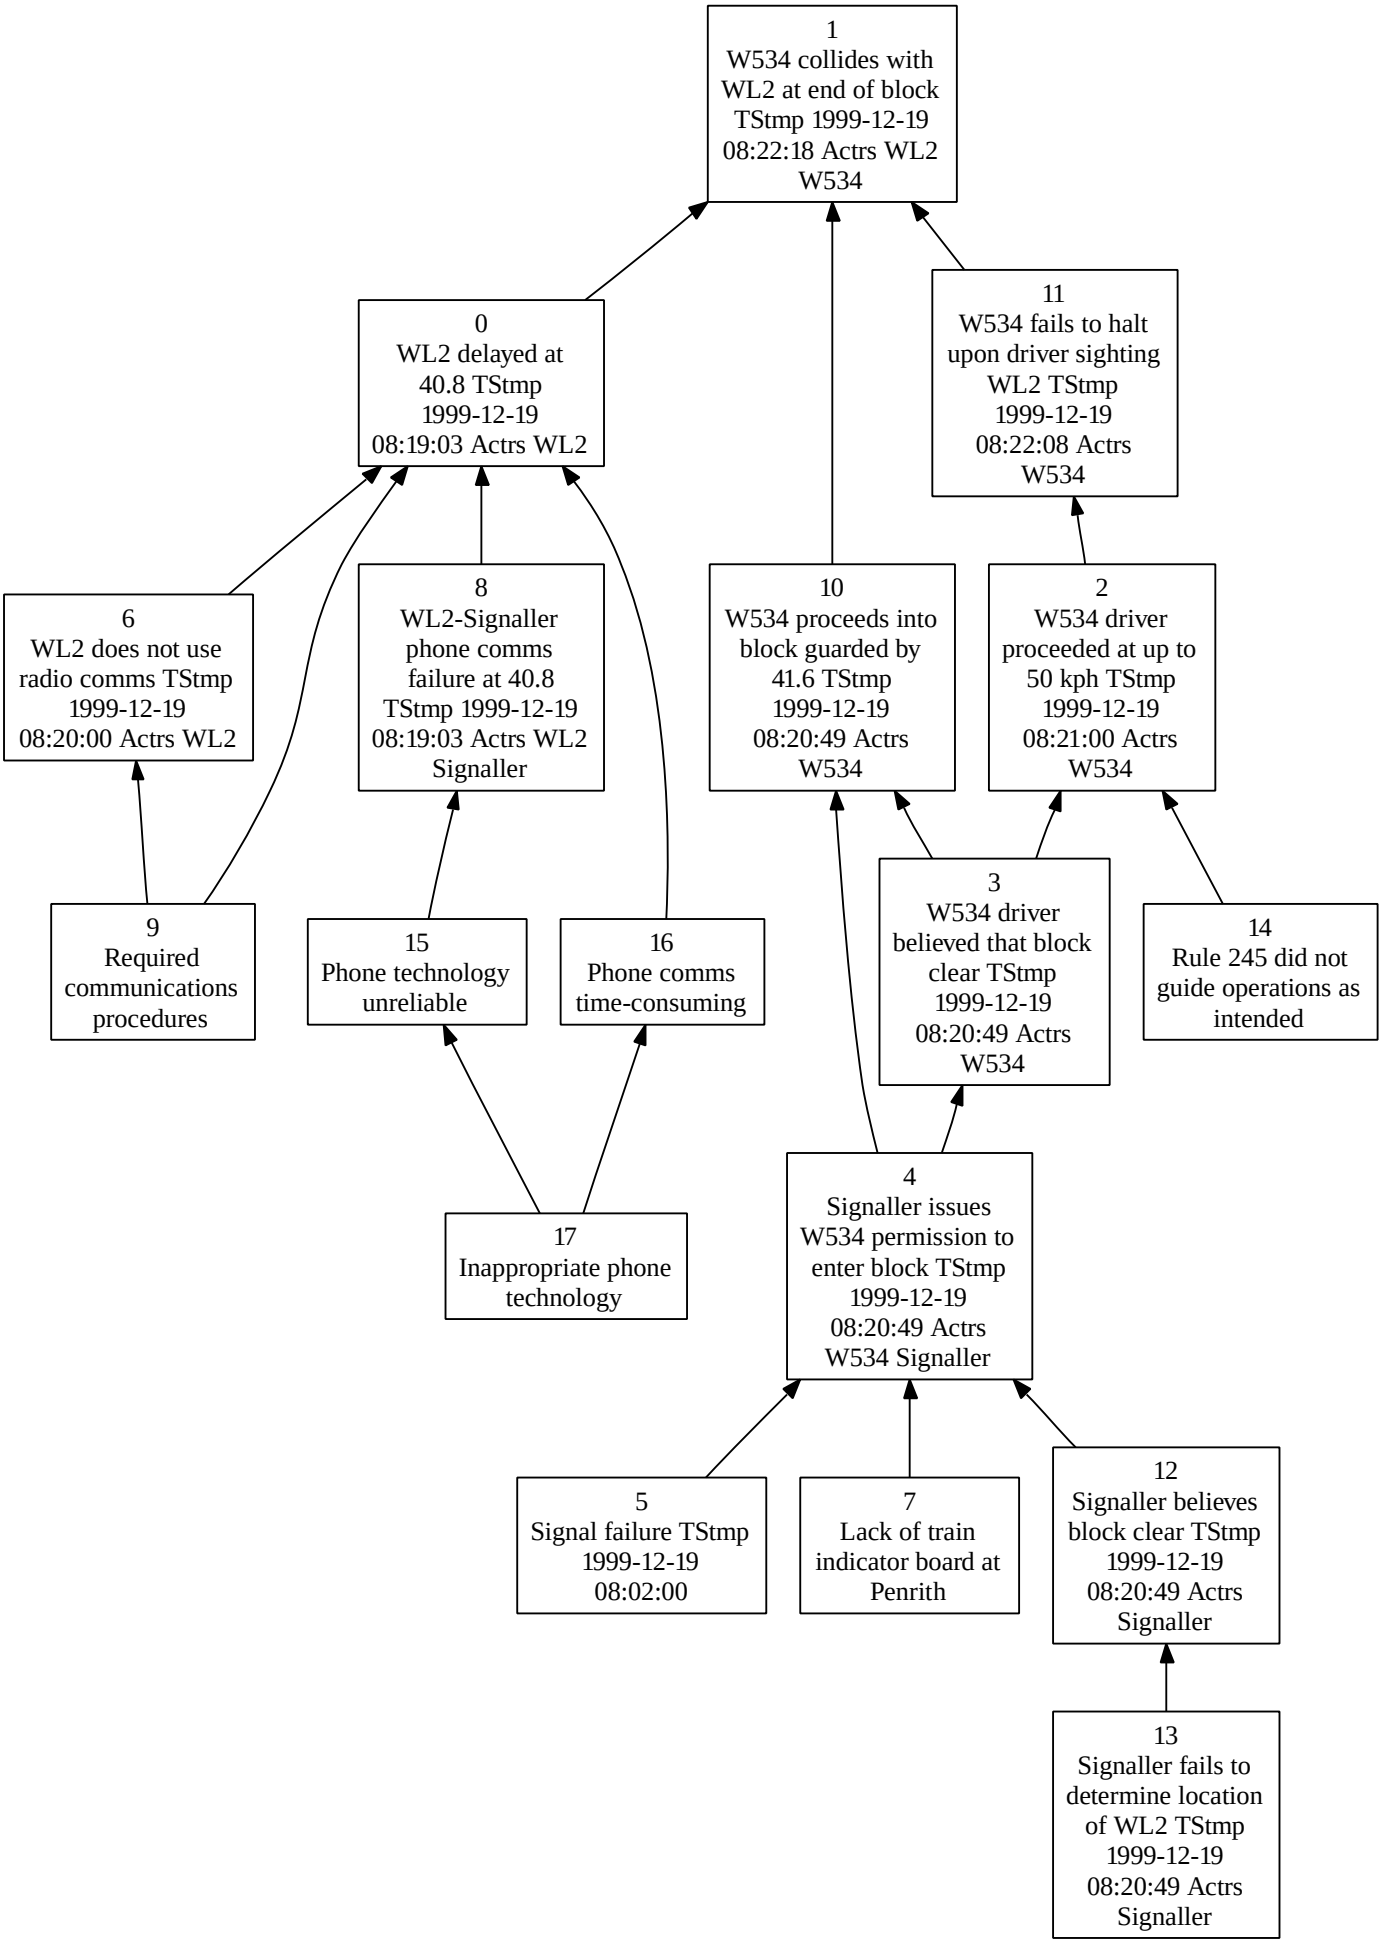
1
W534 collides with WL2 at end of block TStmp 1999-12-19 08:22:18 Actrs WL2 W534
0
WL2 delayed at 40.8 TStmp 1999-12-19 08:19:03 Actrs WL2
11
W534 fails to halt upon driver sighting WL2 TStmp 1999-12-19 08:22:08 Actrs W534
6
WL2 does not use radio comms TStmp 1999-12-19 08:20:00 Actrs WL2
8
WL2-Signaller phone comms failure at 40.8 TStmp 1999-12-19 08:19:03 Actrs WL2 Signaller
10
W534 proceeds into block guarded by 41.6 TStmp 1999-12-19 08:20:49 Actrs W534
2
W534 driver proceeded at up to 50 kph TStmp 1999-12-19 08:21:00 Actrs W534
9
Required communications procedures
15
Phone technology unreliable
16
Phone comms time-consuming
3
W534 driver believed that block clear TStmp 1999-12-19 08:20:49 Actrs W534
14
Rule 245 did not guide operations as intended
17
Inappropriate phone technology
4
Signaller issues W534 permission to enter block TStmp 1999-12-19 08:20:49 Actrs W534 Signaller
5
Signal failure TStmp 1999-12-19 08:02:00

7
Lack of train indicator board at Penrith
12
Signaller believes block clear TStmp 1999-12-19 08:20:49 Actrs Signaller
13
Signaller fails to determine location of WL2 TStmp 1999-12-19 08:20:49 Actrs Signaller
