The Cairns Tilt-Train Derailment in Queensland

An Overview and Partial Analysis

Prof. Peter B. Ladkin PhD
ladkin@rvs.uni-bielefeld.de

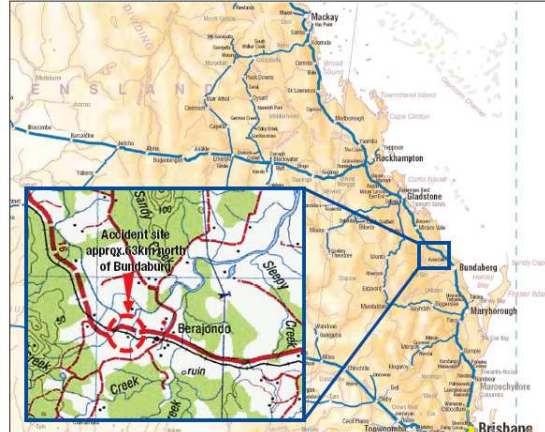
FIGURE 1: Location of Berajondo Accident Site, Queensland

Derailment Location

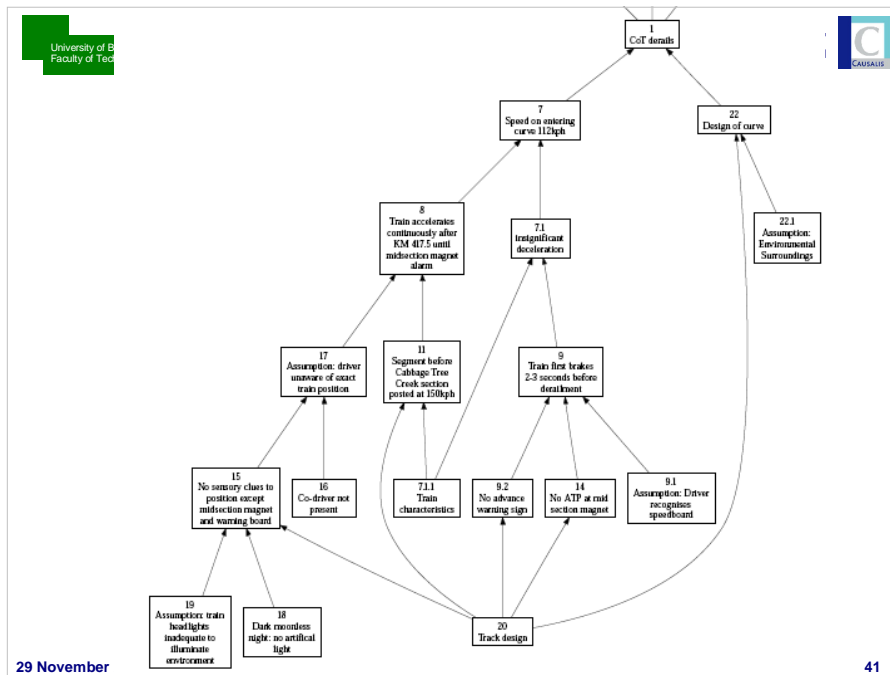
WBG Lower Part: Causes of Derailment

- The WBG is sparse
 - 23 nodes altogether, 18 nodes precursory to derailment
- However, it does identify significant issues
 - Track design: 5 out-edges!
 - Design of curve (general topography of track in vicinity)
 - 1.627 km segment posted 150 kph followed by posted-60-kph curve
 - MSM 0.415 km before 60-kph SPB
 - Few sensory clues to position
 - SPB and MSM
 - Moonless night. Headlights inadequate?
 - Train
 - accelerated continuously for 4+ km previous to POD
 - braked 2-3 sec before derailment (driver saw 60-kph SPB?)
