SURVIVAL FACTORS GROUP FACTUAL REPORT OF
INVESTIGATION

A. ACCIDENT : **DCA97MA058**

LOCATION : Nimitz Hill, Guam, Mariana Islands
DATE : August 6, 1997
TIME : 0142 Local Time
AIRPLANE/OPERATOR : Boeing 747-3B5B (300), S/N 22487,
Flight 801, Operated by Korean Air

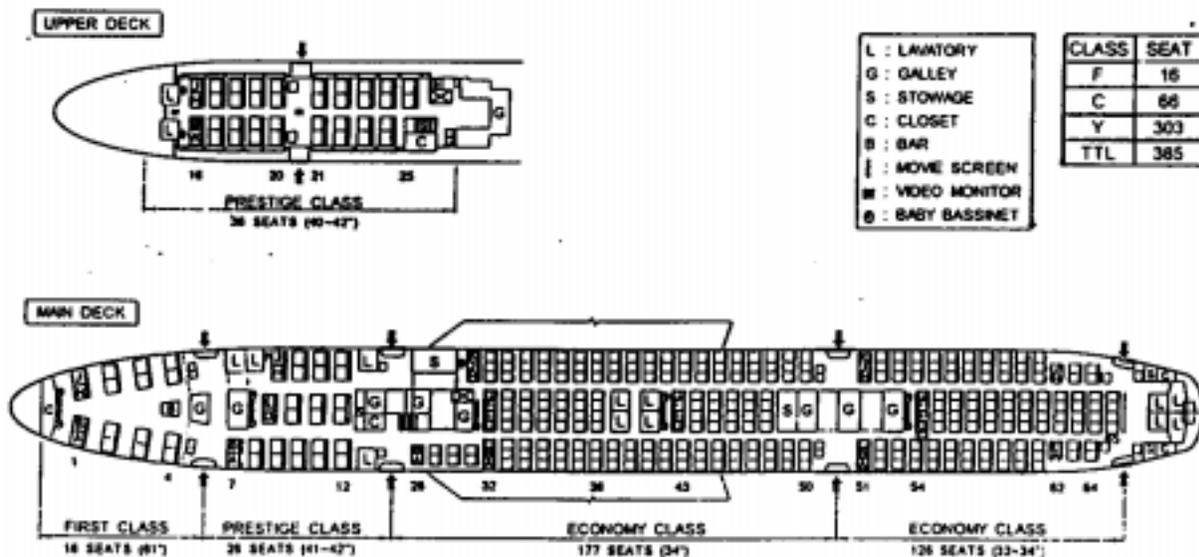
There were 4 rear facing double occupancy flight attendant jump seats and 6 rear facing single occupancy flight attendant jump seats each equipped with 4-point restraint systems. Five emergency exit doors were located on each side of the cabin. (See Figure 1 for location of the cabin configurations and emergency exits.)

Cabin Configuration

1. Airplane Configuration (See Figure 1)

There were 303 seats in economy class divided into three sections longitudinally separated by two aisles. On the left there were 104 seats, in the center there were 100 and on the right side there were 99.

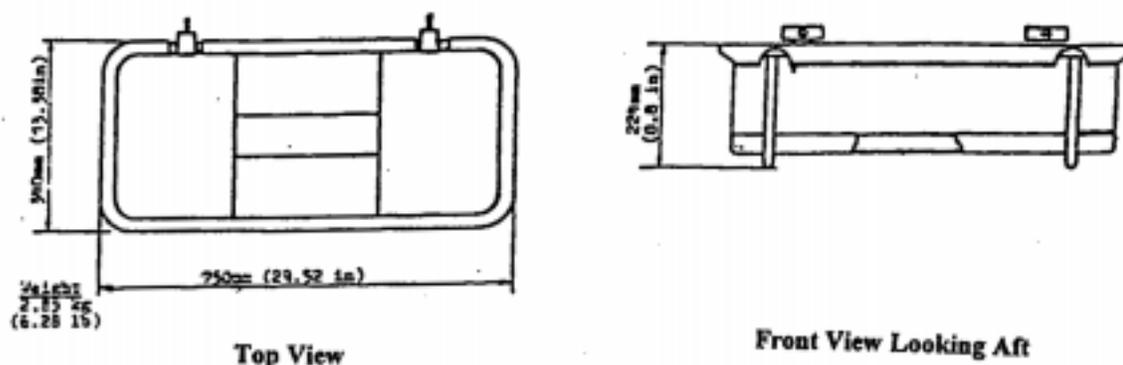
The cabin also had bassinets for infants for in-flight use only, and not for takeoff and landing. The bassinets could be installed on the aft wall of the closet in first class; on the aft wall of the galley's near rows 7, 32 and 54, seats E and D, and seats D, E, F, and G respectively; and on the aft wall of the lavatory in front of row 43, seats D, E, F, and G as required. A diagram of the bassinet is shown in Figure 2 below:

Figure 2
Baby Bassinet
