# Air Transat Flight 236: The Azores Glider

Peter B. Ladkin  
RVS Group, University of Bielefeld  
*ladkin at rvs.uni-bielefeld.de*

## 1 The Flight

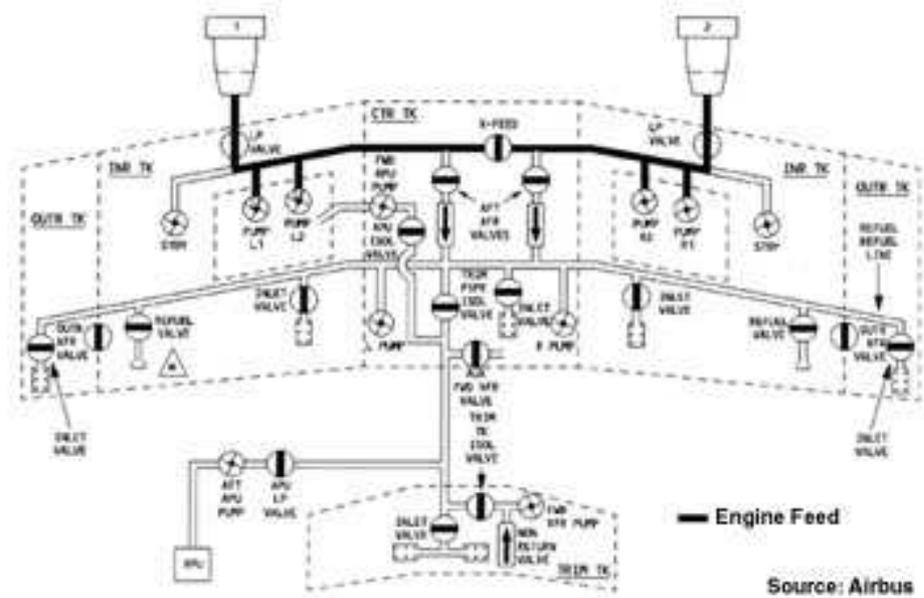
Figure 1: Fuel Schematic for the A330 (from [])

There is a fuel tank, called the “aft trim tank” in the horizontal stabiliser in the rear of the aircraft, which contained 3.2 tonnes of fuel. The main tanks are in the wings, and consist of an inner tank and an outer tank in each wing. The engines are directly fed from the inner tank. Fuel is transferred fully automatically from the aft trim tank into the inner wing tanks to maintain the aircraft in balance (and thus save fuel). Figure 1 shows a schematic diagram of the A330 fuel system.

A message that fuel is being transferred from the aft trim tank is raised on the Electrical Central Aircraft Monitoring (ECAM) system display in the cockpit. The trim tank fuel was transferred into the right inner wing tank, feeding the leak. When the fuel imbalance between the left wing and the right wing had reached 3 tonnes (about equivalent to 36 minutes of cruise flight), a FUEL IMBALANCE warning was raised on the ECAM. The crew ran the FUEL IMBALANCE check list from memory; this included opening the cross-feed valve, which allows fuel to be transferred between the left and right wing tanks to correct the imbalance. This led to fuel being transferred from the left wing tank to the right tank and out through the leak.
